# ATTERBERG LIMITS RESULTS

ASTM D4318

PROJECT: EQUIS Geotech Demo

PROJECT NUMBER: EQUISGEOTECH

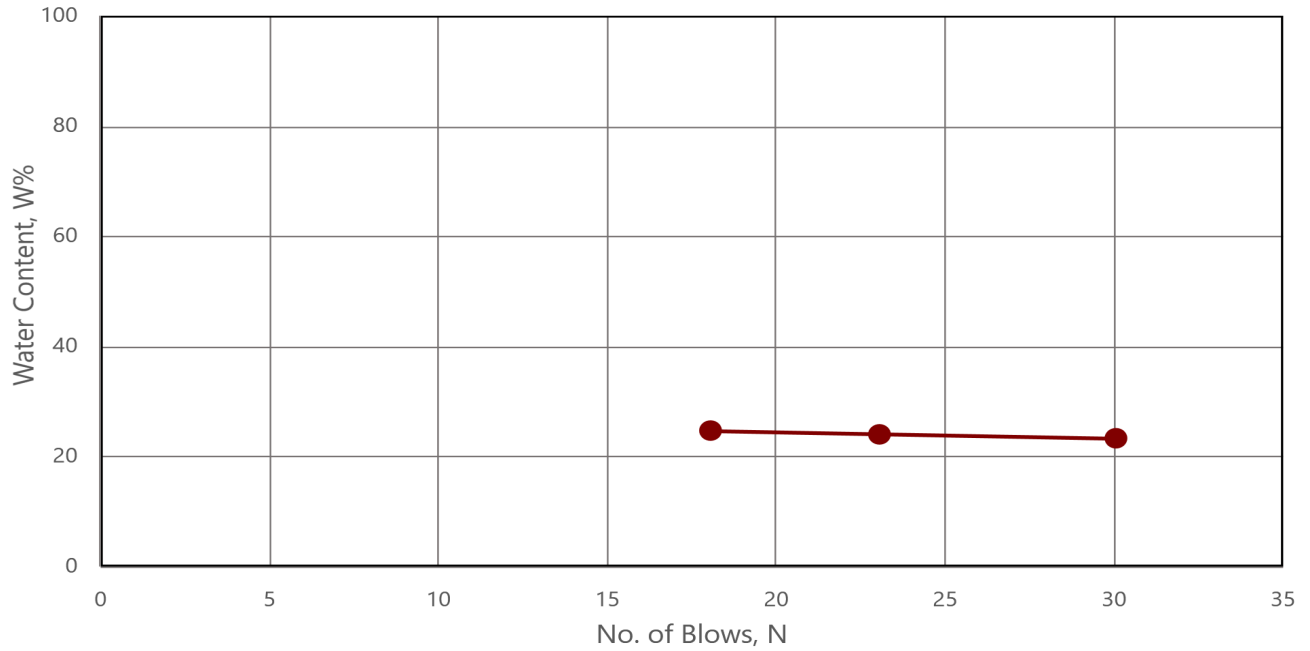
Boring ID	Depth	LL	PL	PI	Fines	USCS	Description
● B-01	6	24	16	8	39.7	SC	CLAYEY SAND

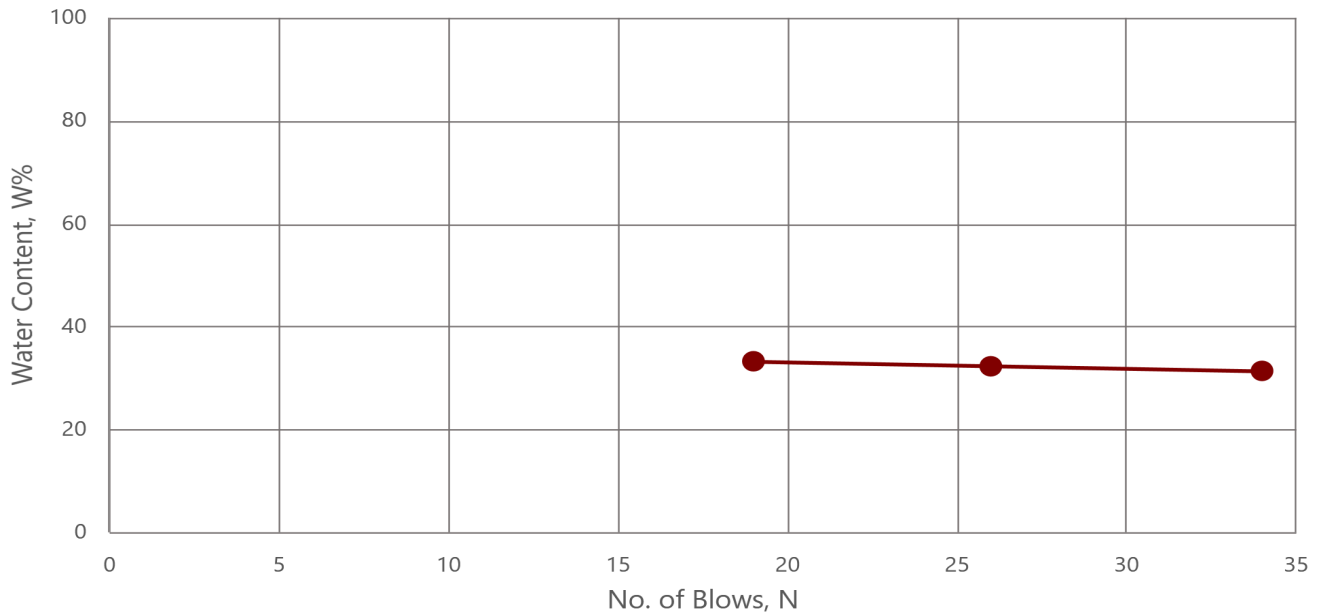
Boring ID	Depth	LL	PL	PI	Fines	USCS	Description
● B-01	23.5	32	16	16	68.9	CL	SANDY LEAN CLAY

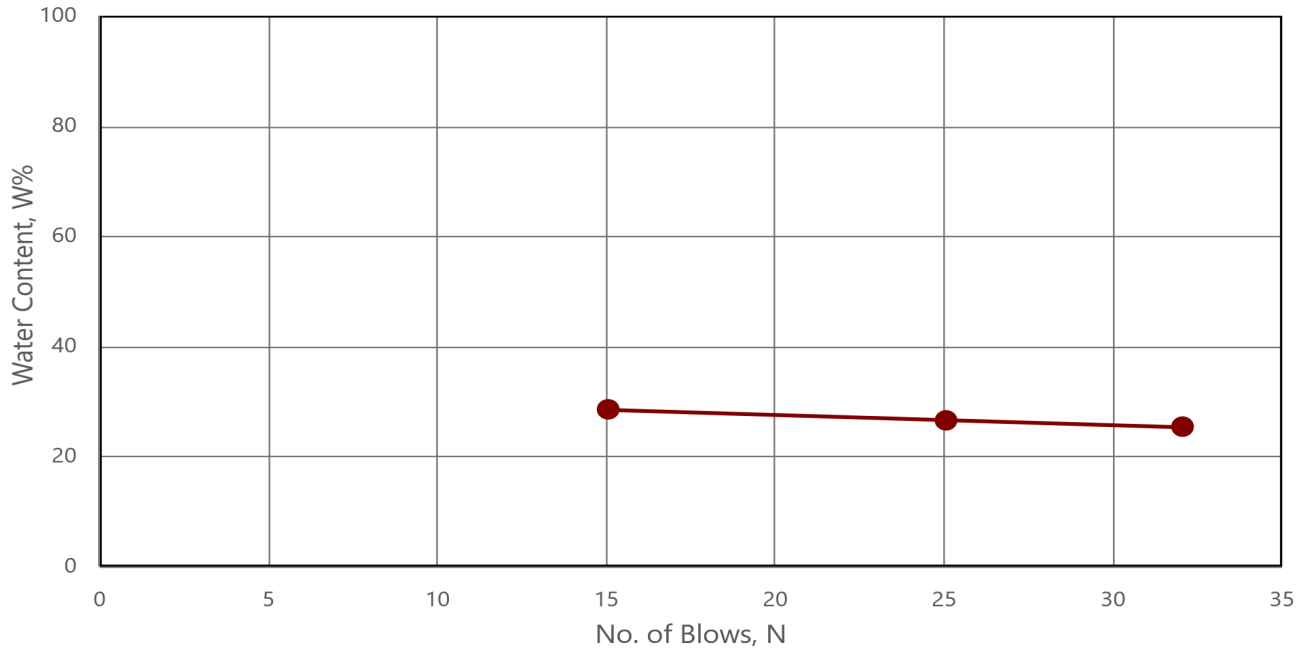
Boring ID	Depth	LL	PL	PI	Fines	USCS	Description
● B-01	33.5	27	12	15	64.1	CL	SANDY LEAN CLAY
