Pore Pressure Dissipation Test Results

PROJECT: EQUIS Geotech Demo
SITE: 123 Discovery Road
Seattle, WA

PROJECT NUMBER: EQUISGEOTECH
CLIENT: EarthSoft
Bellevue, Wa

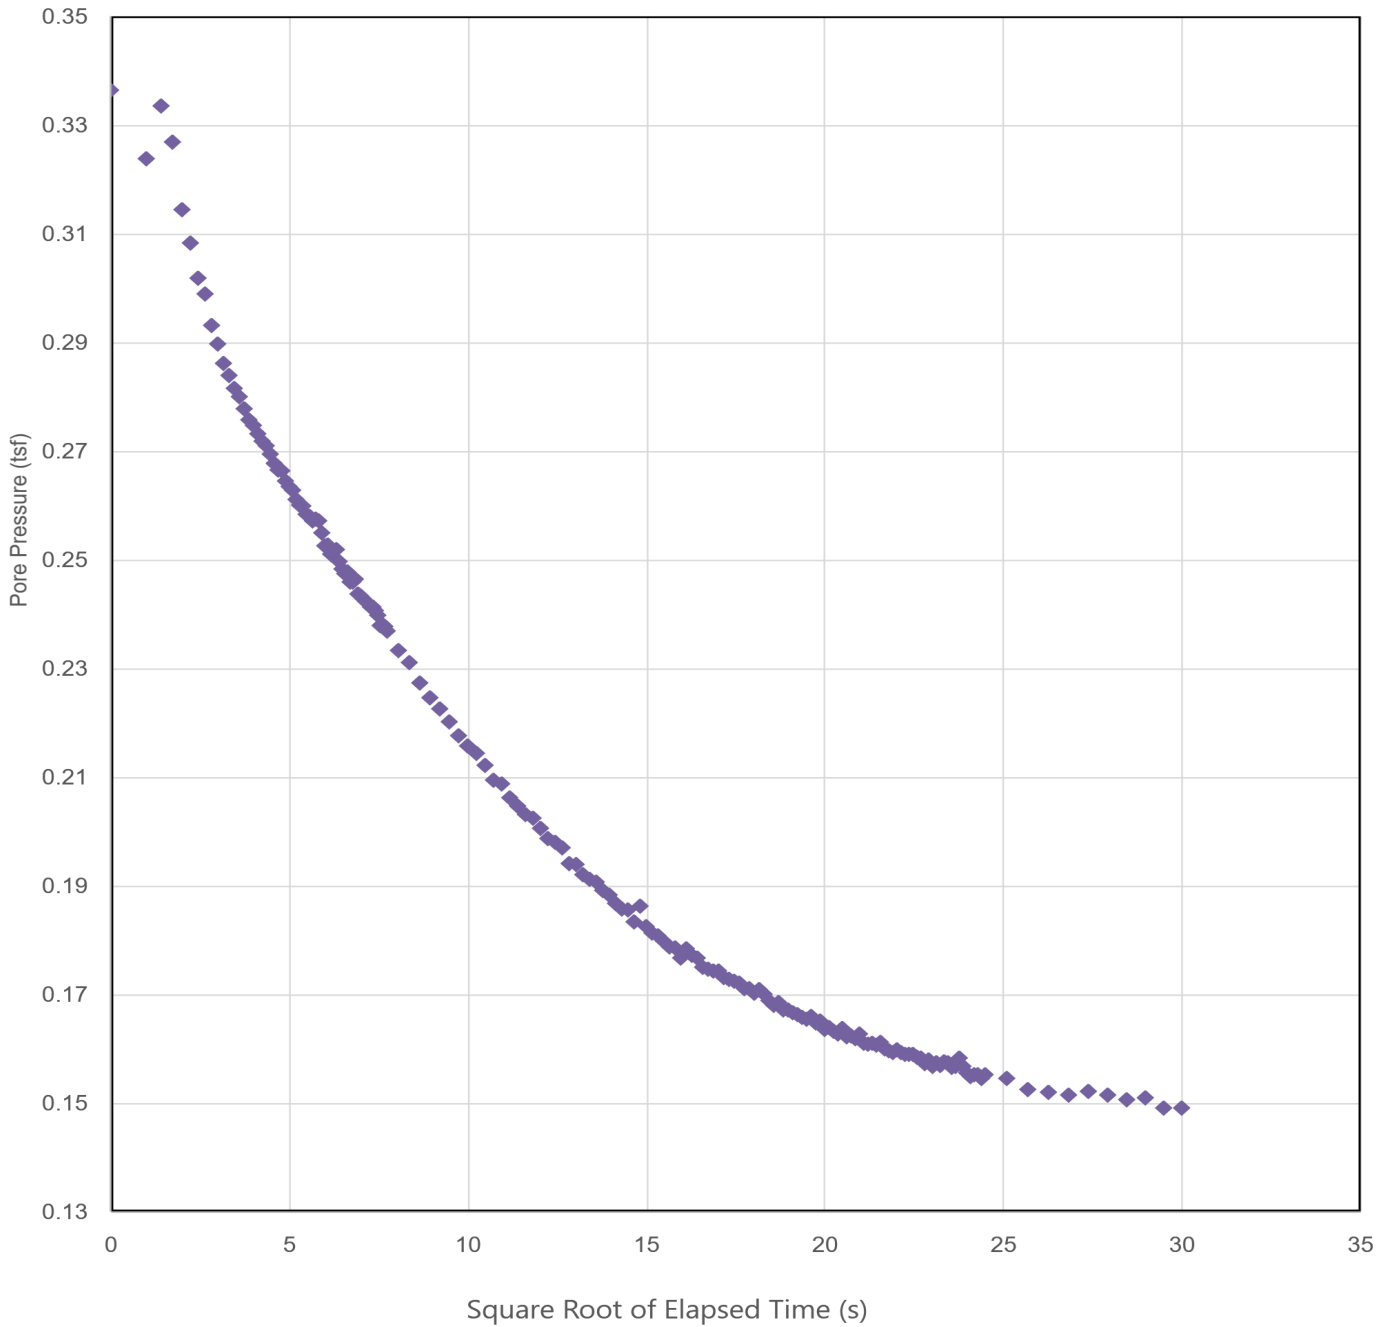
Test CPT-1
Test Depth - ft 15.03
Test Duration - s 900

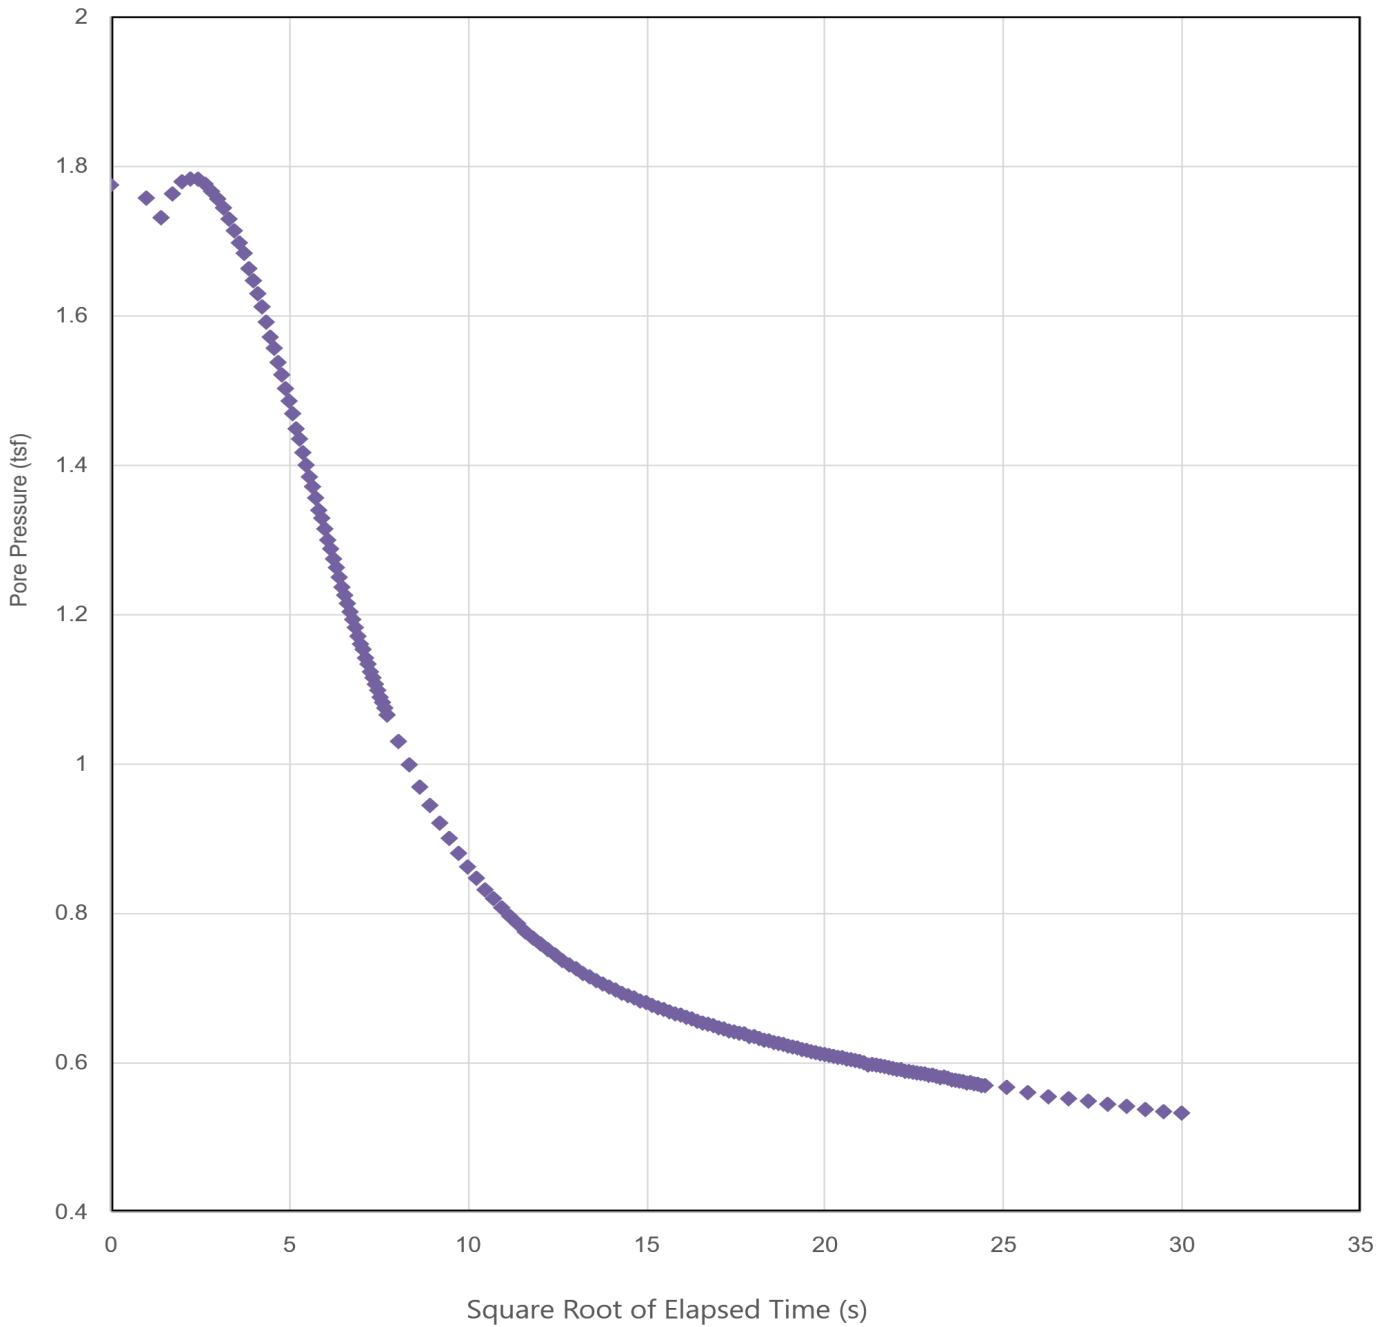
Pore Pressure Dissipation Test Results

Test	CPT-1
Test Depth - ft	29.99
Test Duration - s	900
